**North Slope of Alaska ARM Facilities  
Monthly Status Update  
Sandia National Labs**

**February 2017**

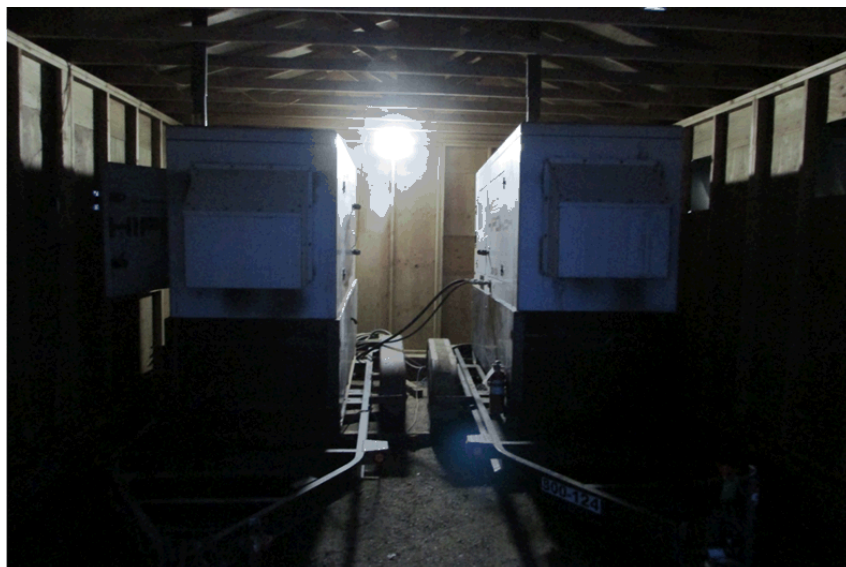
Prime power generators

In December 2016, Delta Leasing, who assumed the Sandia lease, purchased MagTec, who supplied us with our power generators. Some of the mechanic skill set was lost in the purchase. The generators are becoming less reliable as they age and accumulate operational hours. Further, the kW capacity of the present-leased generators has been reached due to the addition of the Arctic Shelters and extra instruments.
